DOCUMENT NO. T5-6539-100

TITLE METALLURGICAL ANALYSIS OF A 504 VEHICLE OXIDIZER TANK  
RING BAFFLE WEB, 60B12550-1 FAILURE

MODEL NO. Saturn V/S-IC CONTRACT NO. NAS8-5608

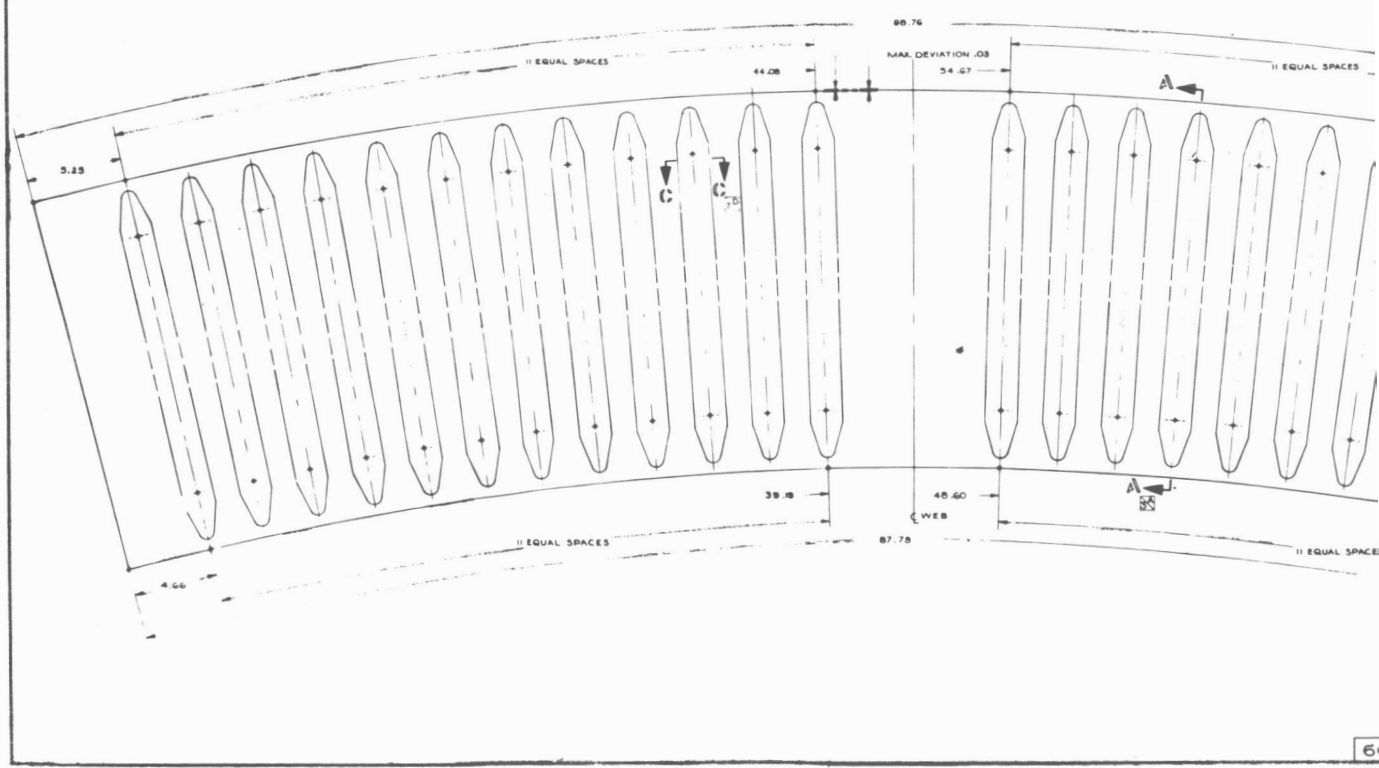
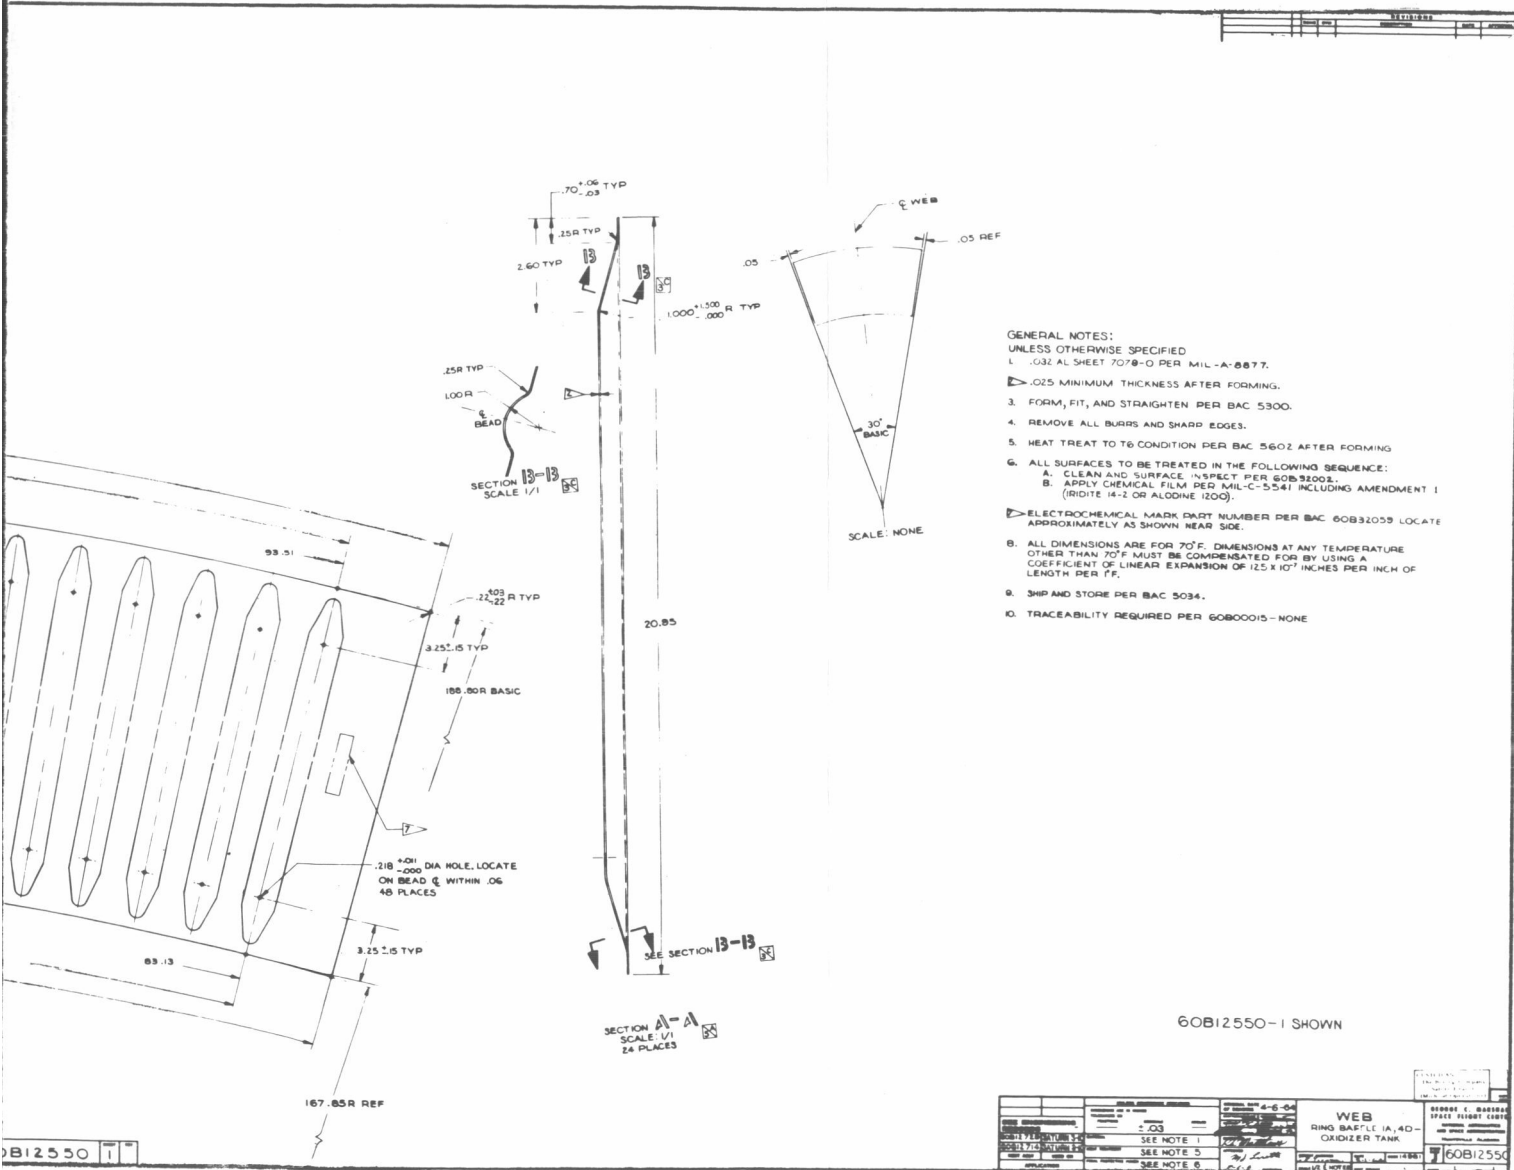
FIGURE 2 - DRAWING 60B12550

The failed web was made from 0.032 inch thick annealed 7079 aluminum alloy sheet, which was formed and then heat treated to the T6 temper. The drawing for 60B12550 is shown in figure 2. The web is installed in the Ring Baffle Segment Assembly, 60B12714-3.
